**INTEGRATION OF GEOREFERENCED INFORMED SYSTEM AND DIGITAL IMAGE
ANALYSIS TO ASSES THE EFFECT OF CARS POLLUTION ON HISTORICAL CITIES.**

R. Ortiz^{*a}, P. Ortiz^a, M.A. Vázquez^b, J.M. Martín^a

^aUniversidad Pablo de Olavide, Department of Physical, Chemical and Natural
Systems. Carretera de Utrera Km 1, ES-41013 Sevilla, España

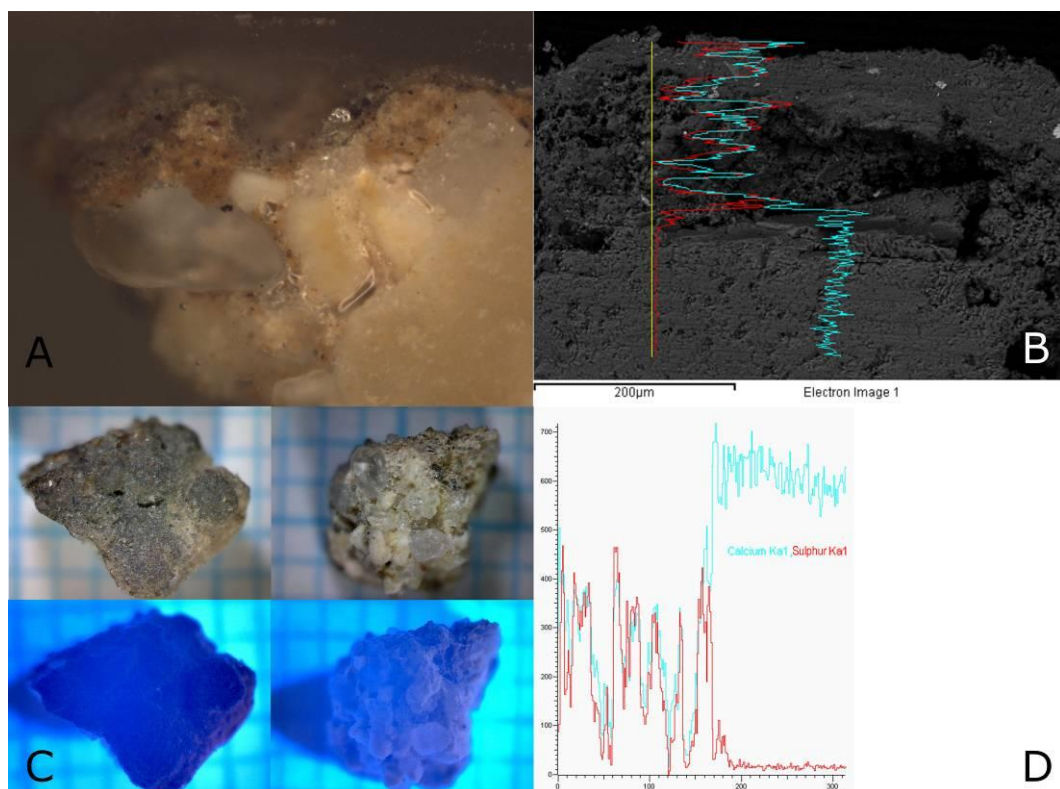
Crust and deposit sections perpendicular to the studied surface were analysed using a scanning electron microscope coupled with energy dispersive spectroscopy [43]; more than 120 samples were considered, of which 80 % contained sulphur and calcium, indicating chemical reactions with sulphur oxides from the atmosphere. The crust layers varied in thickness from 20–1000 μm . Figure 4 shows the image of the black crust found on the Santa Cruz church, in which sulphur and calcium were detected in the exterior layer by SEM-EDX (Figures 4B and D). Above the layer of gypsum, particles and compounds that generate the black colour of the crust accumulate (Figure 4A shows the cross-section, and Figure C shows the parallel cut).

Figure 4. A) Stratigraphy of sample from Santa Cruz church viewed with an optical microscope; black and brown deposits are visible, with a thickness range of 150–300 μm . B and D) Scanning electron microscope image coupled with energy dispersive spectroscopy; visible layers of sulphur and calcium are detected on the surface. C) Magnified images under visible and ultraviolet light of the front and back of a crust sample (scale = 1 mm); the extent of blackening may be observed.

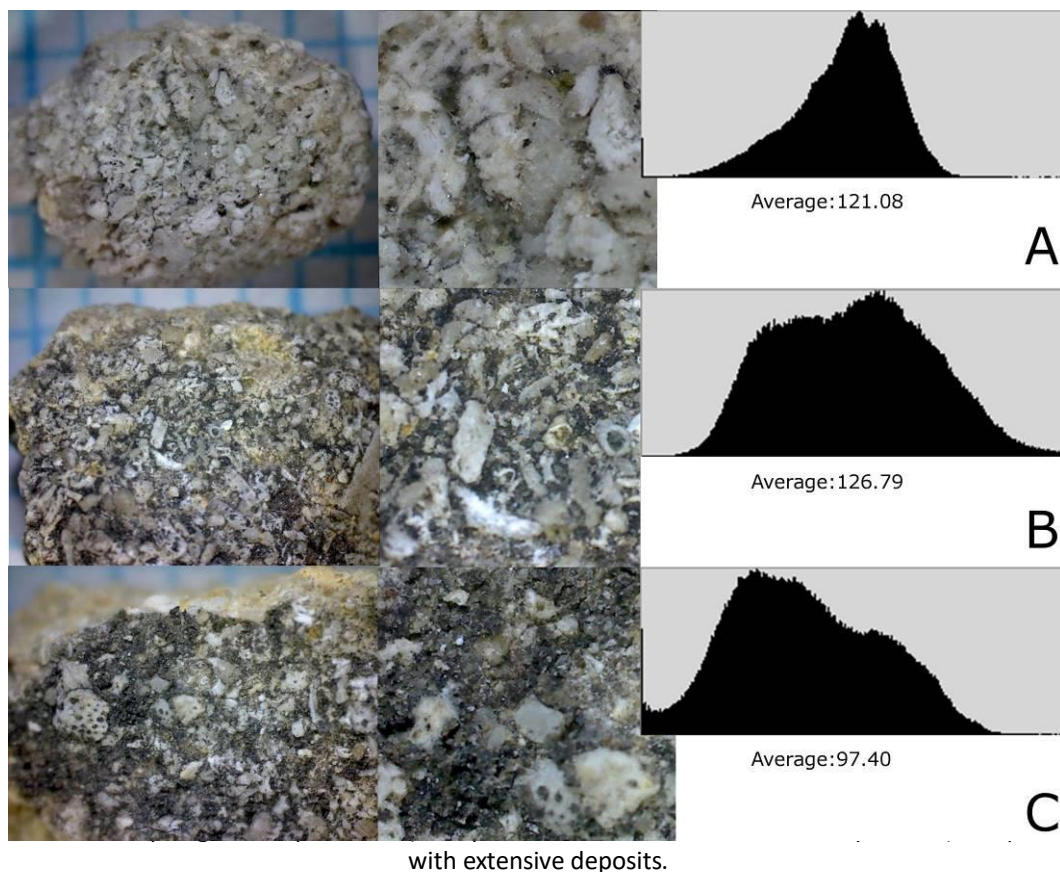
Based on the degree of alteration, crusts may be classified as fine, intermediate or high thickness using DIA (Figure 5). The histograms of the digital images shift as a function of the degree of alteration. In Figure 5, several samples from the Santa Catalina church with varying levels of crust may be observed. In Figure 5A, the histogram shifts towards the right, indicating higher levels of white and fewer deposits, and when the surface is covered with intermediate levels of crust (Figure 5B), the histogram is centred. Finally, for the most altered samples with the highest levels of deposits (Figure 5C), the histogram is shifted to the left. This displacement of the histogram values obtained by DIA allows us to view the different stages of the formation of black crusts and/or deposits, from beginning to advanced.

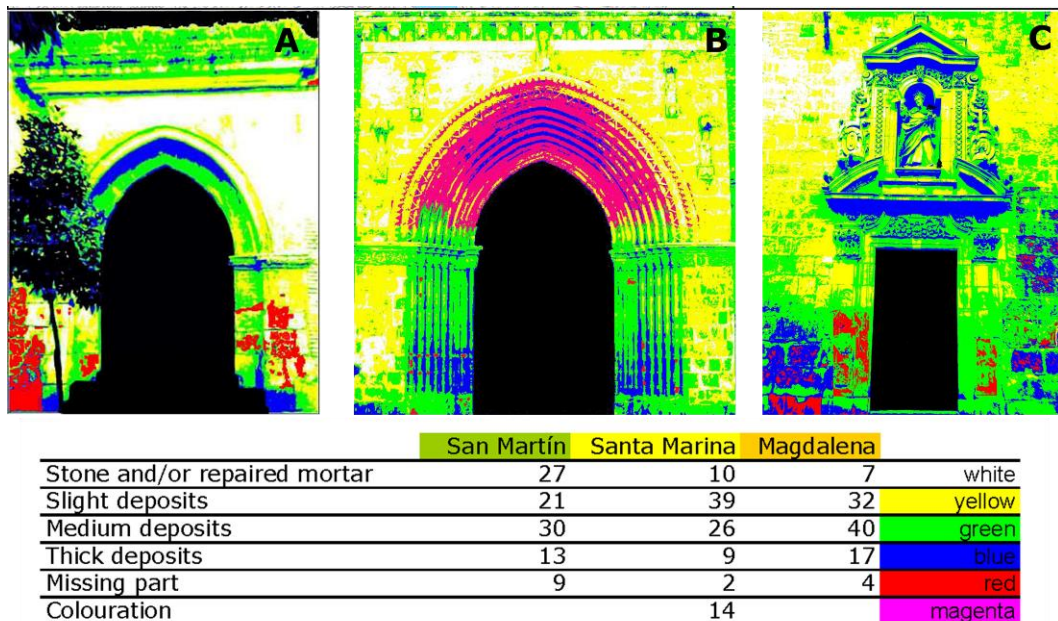
In Figure 8, the DIA of the facades of the churches Magdalena, Santa Marina, and San Martín is shown; these are located on streets with high, medium, and low levels of traffic, respectively. This analysis reveals the appearance of crusts and/or deposits (yellow, green, and blue colours) on 89 %, 74 %, and 64 % of the analysed surfaces. Over the course of time, all churches exhibit an overall blackening of more than 60 % of their facade as a consequence of the wet and dry deposition of pollutants and airborne particulates, including San Martín,

despite its location on a low-traffic street. This result may be due to the cleaning and restoration of the facades of Santa Marina and Magdalena in 1993 and 1991, respectively, whereas the facade of San Martín has not received these efforts. Thus, deposits have accumulated on its facade for a longer period of time.

Figure 8. A Digital image analysis of the San Martín church facade. B Digital image analysis of the Santa Marina church facade. C Digital image análisis of the Magdalena church facade. Percentage of alteration on facade surface.

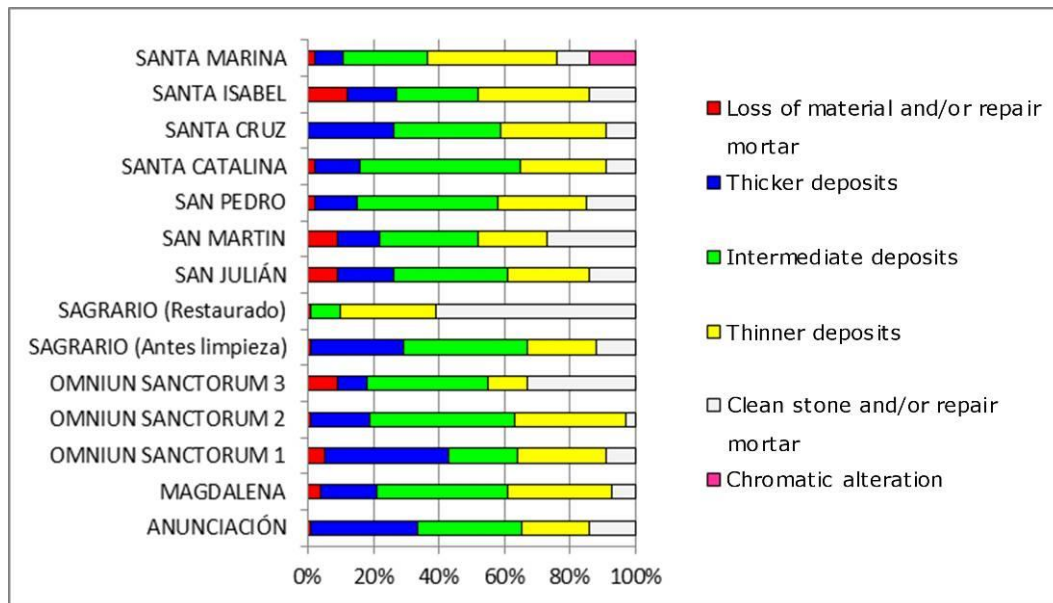
The present analysis was applied to a total of 10 churches (13 facades). In Figure 9, the quantification of the extent of alterations may be observed. Churches along roadways with high levels of traffic (San Pedro, Magdalena, Omnium Sanctorum facade 1, Santa Cruz, Santa Catalina, and Anunciación) have more than 80 % of their facades covered with crusts and deposits, whose thickness depends on the time since the most recent restoration, level of traffic, and street width.

Figure 9. Percentage of alteration on facade surface via digital image analysis.

Facade 2 of Omniun Sanctorum and the Sagrario facade, before its cleaning, presented similarly high values of alteration despite being situated on streets with low traffic. In the case of Omniun Sanctorum, the time since the last restoration, as well as the presence of parking spaces near its entrance until 2013, may be the possible causes. In the case of Sagrario, Constitución Avenue is currently pedestrianised, although it was previously one of the streets with the highest levels of traffic in the city centre and one of the main public transportation routes for buses. These results coincide with recent research performed by Ruffolo et al (2015) that showed that black crusts from the Cathedral of Seville are primarily due to vehicular traffic pollution, where the difference in thickness is due to different exposures to vehicular traffic.
